Inspection Photos

I00090053+07231

Location 10 KM E SUPERIOR Stucture Name: none

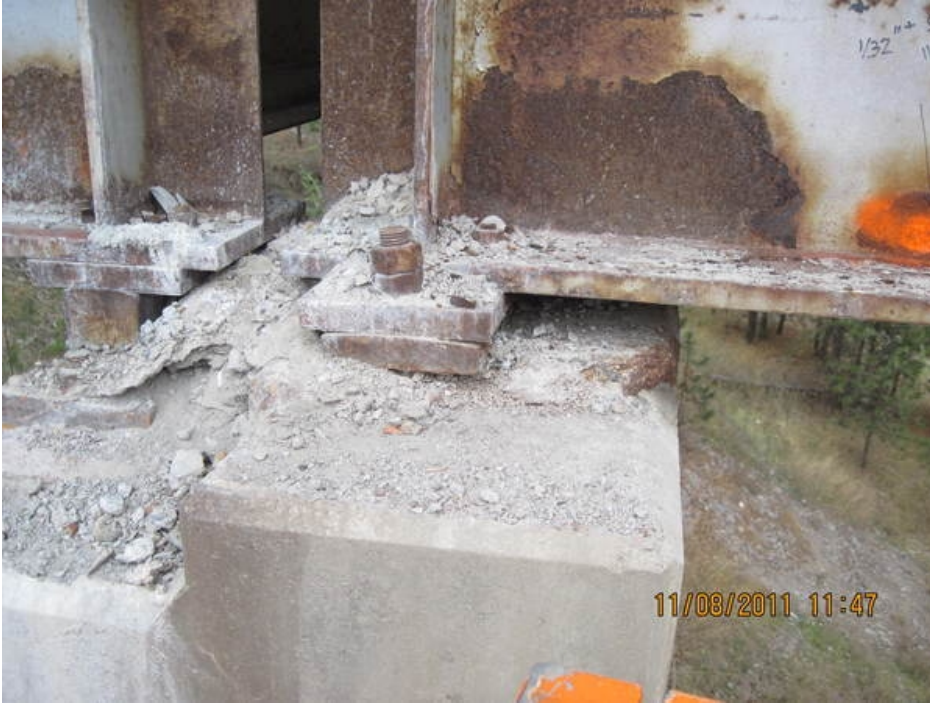
Bent 2 bearing pad

Bent 2 span 2 bearing pad second from the left. Same location photo taken 2009 inspection. Bearing pads throughout continue to deteriorate.
